Emergency Repair – Anderson Building

Project: F. Anderson Bldg Wall Reconstruction
Client: Sun Windows of Owensboro, KY

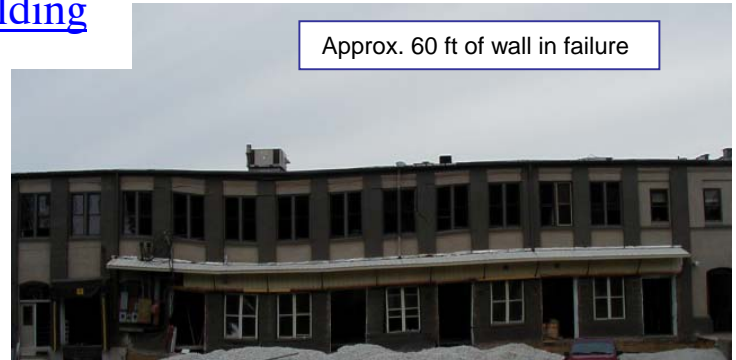
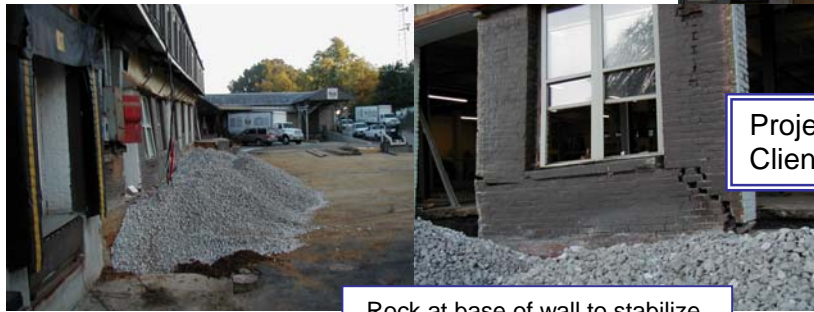
During construction activity around the dock of the Anderson Building, workers got an unpleasant surprise when a 60 ft segment of a 2-story un-reinforced masonry wall partially collapsed as the footing beneath was accidentally disturbed.

Rock at base of wall to stabilize

First, approximately 100 tons of rock were placed at the base of the wall for lateral stability. Then, temporary steel columns were placed beneath 2nd floor timber beams, carefully located at a safe distance to provide support and to allow room for reconstruction. Finally, a second line of temporary timber columns was placed directly above the steel columns to stabilize the roof.

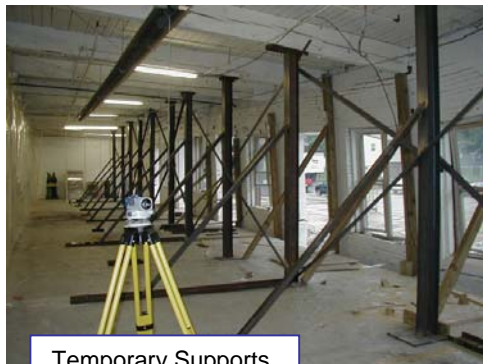
Temporary Supports

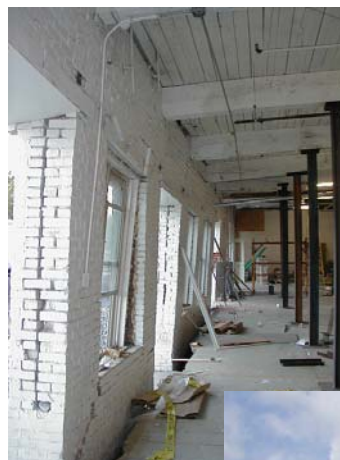
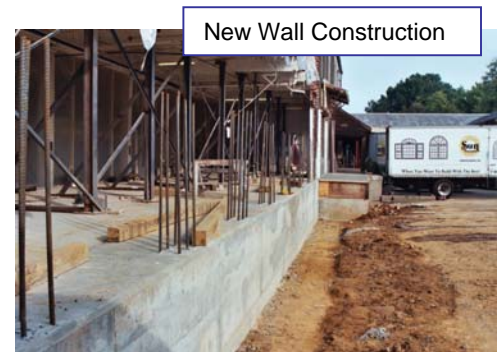
New Wall Construction

THA Engineering Solutions designed a new wall section for the dock and 2-story building. Constructability was a key in working with Contractor to design a solution to facilitate construction around existing structure. The wall was replaced within weeks of the accident.
